National Transportation Safety Board Aviation Accident Final Report

Location:	Elizabethton, TN	Accident Number:	ERA19FA248
Date & Time:	08/15/2019, 1537 EDT	Registration:	N8JR
Aircraft:	Textron Aviation Inc 680A	Aircraft Damage:	Destroyed
Defining Event:	Runway excursion	Injuries:	3 Minor, 2 None
Flight Conducted Under:	Part 91: General Aviation - Business

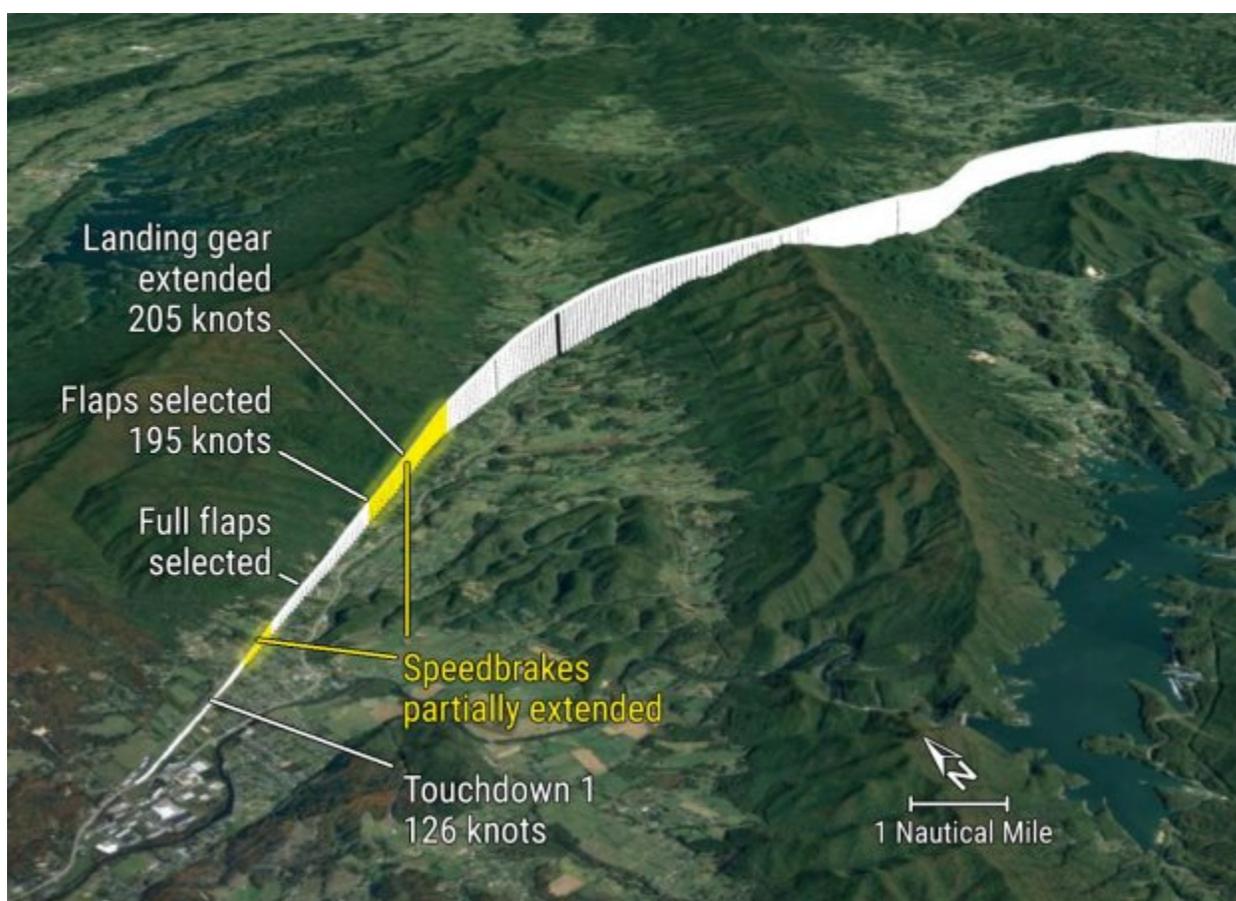
As the approach continued, the airplane crossed a ridgeline at 710 ft above ground level (agl), which triggered a terrain awareness and warning system (TAWS) alert. Further, the flight crew made several comments about the airplane flying too fast and allowed the airspeed to increase well above the reference speed (V_{ref}) for the approach. At 1535:57 (about 1 minute 52 seconds before landing), the pilot pulled back the throttles to idle, where they stayed for the remainder of the approach. In an attempt to slow the airplane for landing, the pilot partially extended the speedbrakes when the airplane was below 500 ft agl, which is prohibited in the airplane flight manual (AFM). Five seconds before touchdown, the airplane's descent rate was 1,500 ft per minute (fpm), which exceeded the maximum allowed for landing per the AFM of 600 fpm.

The airplane's approach was unstabilized: its airspeed during the approach and landing well exceeded V_{ref} and its descent rate exceeded the maximum allowed for landing just seconds before touchdown. Both the pilot and copilot commented on the airplane's high speed several times during the approach. During short final, the pilot asked the copilot if he should go around, and the copilot responded, "no." Although the copilot was the director of operations for the flight department and the direct supervisor of the pilot, the pilot stated that the copilot's position did not influence his decisions as pilot-in-command nor did it diminish his command authority. Neither the pilot nor copilot called for a go-around before landing despite awareness that the approach was unstabilized.

Figure 1: N8JR's approach, including speed and use of speedbrakes (in yellow), landing gear, and flaps.

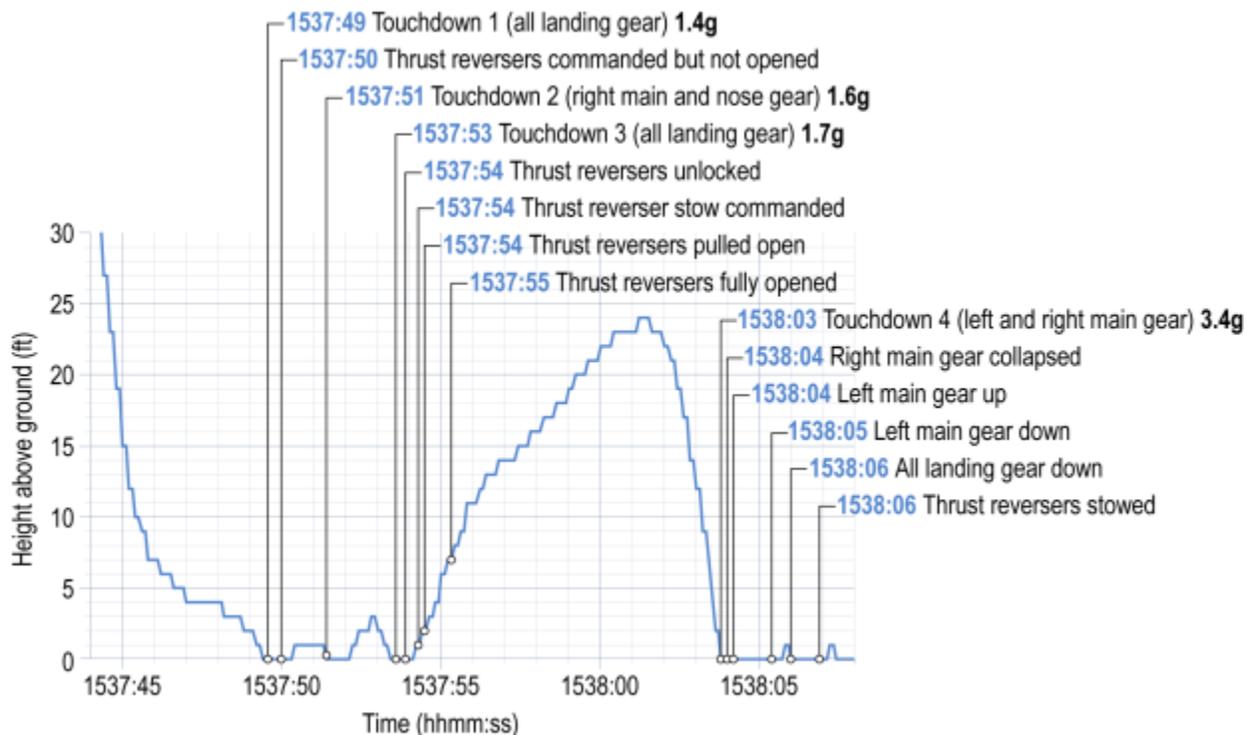
Figure 2. Graph depicting the airplane's thrust reverser actions, landing gear touchdowns, and vertical acceleration (**bold**) during its bounced landing.

When the airplane touched down initially at 1537:49, it was travelling 126 knots (18 knots above V_{ref}) and had a descent rate of 600 fpm (the maximum allowed per the airplane flight manual [AFM]). All three landing gear registered "on-ground" simultaneously with a vertical acceleration of 1.4 gravitational acceleration (g), and thrust reverser deployment was commanded 0.4 second after the landing gear first touched the ground as the throttles were moved to the reverse idle position; however, the airplane bounced after touching down for 0.6 second and was airborne again before the thrust reverser command could be executed.

When the airplane touched down a second time, 1.2 seconds later at 1.6 g, the nose landing gear touched down first, followed immediately by the right main landing gear. The left main landing gear never registered on-ground during the touchdown, and the airplane bounced and became airborne again after 0.4 second.

The airplane touched down a third time, 1.8 seconds later at 1.7 g and about 1,000 ft down the runway with about 3,100 ft of paved surface remaining. The thrust reversers unlocked 0.4 second after all three landing gear registered on-ground because the reverser deployment command from the first touchdown was still active. Almost immediately after the thrust reversers unlocked, the pilot advanced the throttles to idle, sending a thrust reverser stow command at 1537:54; however, the landing gear status changed to "in-air" almost simultaneously when the command was executed.

The airplane bounced after 0.6 second and became airborne a third time, and the in-air landing gear status triggered a cut in hydraulic power to the thrust reverser actuators, which is intended to prevent the airborne deployment of a thrust reverser. The cut in hydraulic power to the thrust reversers allowed the unlocked thrust reversers to be pulled open by aerodynamic forces. The amber "T/R UNLOCK CAS" message illuminated and the thrust reverser emergency stow switches began to flash. The pilot advanced the throttles to maximum takeoff power 0.7 second later in an attempt to go around; however, the thrust reversers reached full deployment 0.4 second after that. The airplane's full authority digital engine controls (FADEC), by design, prevented an increase in engine power while the thrust reversers were deployed. The red "T/R DEPLOY CAS" message was displayed in the cockpit, indicating that the thrust reversers were deployed, and the thrust reverser emergency stow switches continued to flash.

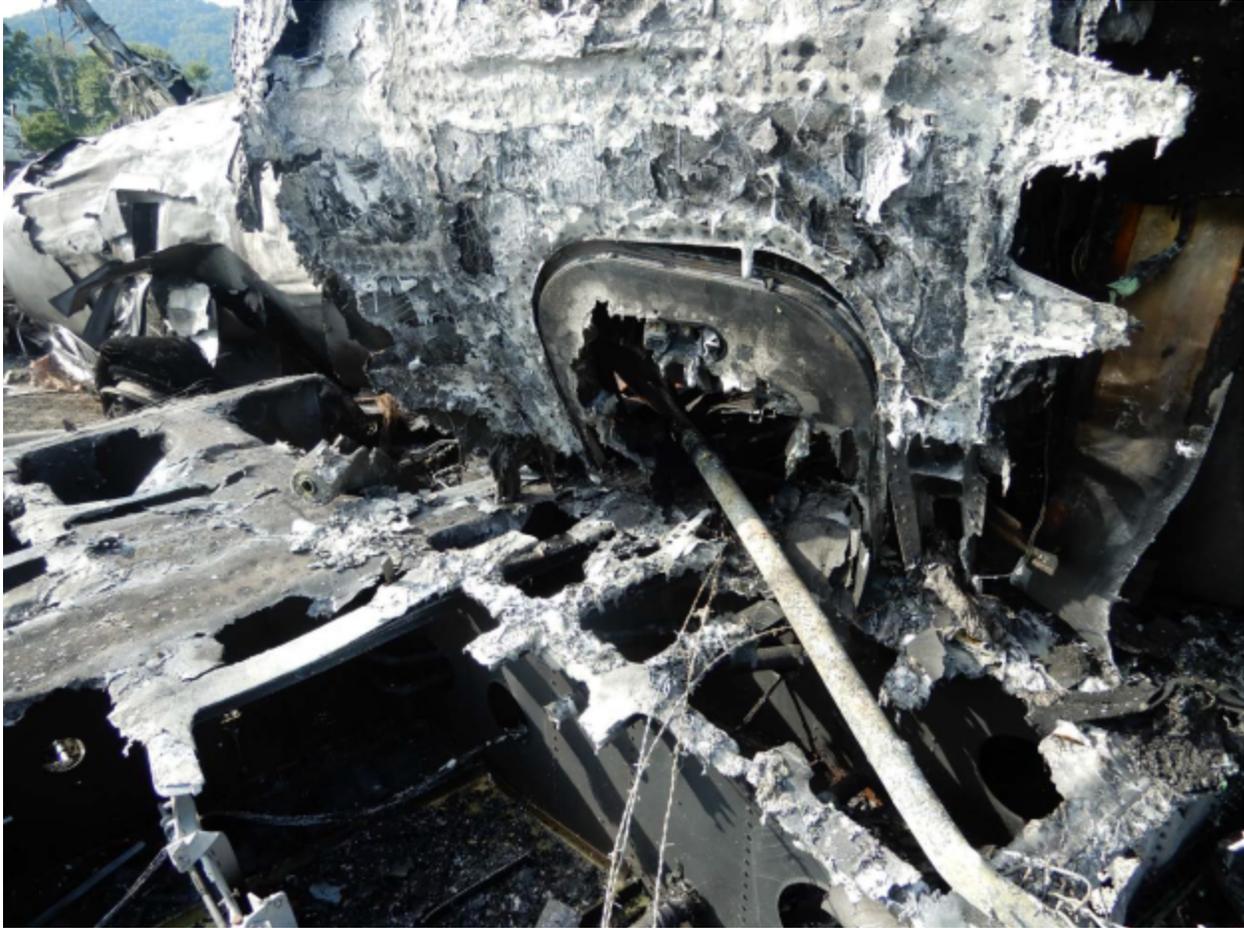
The pilots and passenger continued to struggle with the emergency escape hatch and observed heavy smoke coming from the lavatory, followed by flames. The copilot attempted to open the cabin entry door a second time, and he was able to push the door partially open with enough clearance to get all the occupants out. In a postaccident interview, the copilot reported that the exterior handle was likely pushing against the ground at the time, preventing it from opening fully.

Figure 3: Emergency escape hatch impaled by a metal fence post.
