# Aviation Investigation Final Report

<b>Location:</b>	Victoria, Minnesota	<b>Accident Number:</b>	CEN21FA360
<b>Date &amp; Time:</b>	August 7, 2021, 17:40 Local	<b>Registration:</b>	N9156Z
<b>Aircraft:</b>	Mooney M20M	<b>Aircraft Damage:</b>	Destroyed
<b>Defining Event:</b>	Loss of control in flight	<b>Injuries:</b>	3 Fatal
<b>Flight Conducted Under:</b>	Part 91: General aviation - Personal

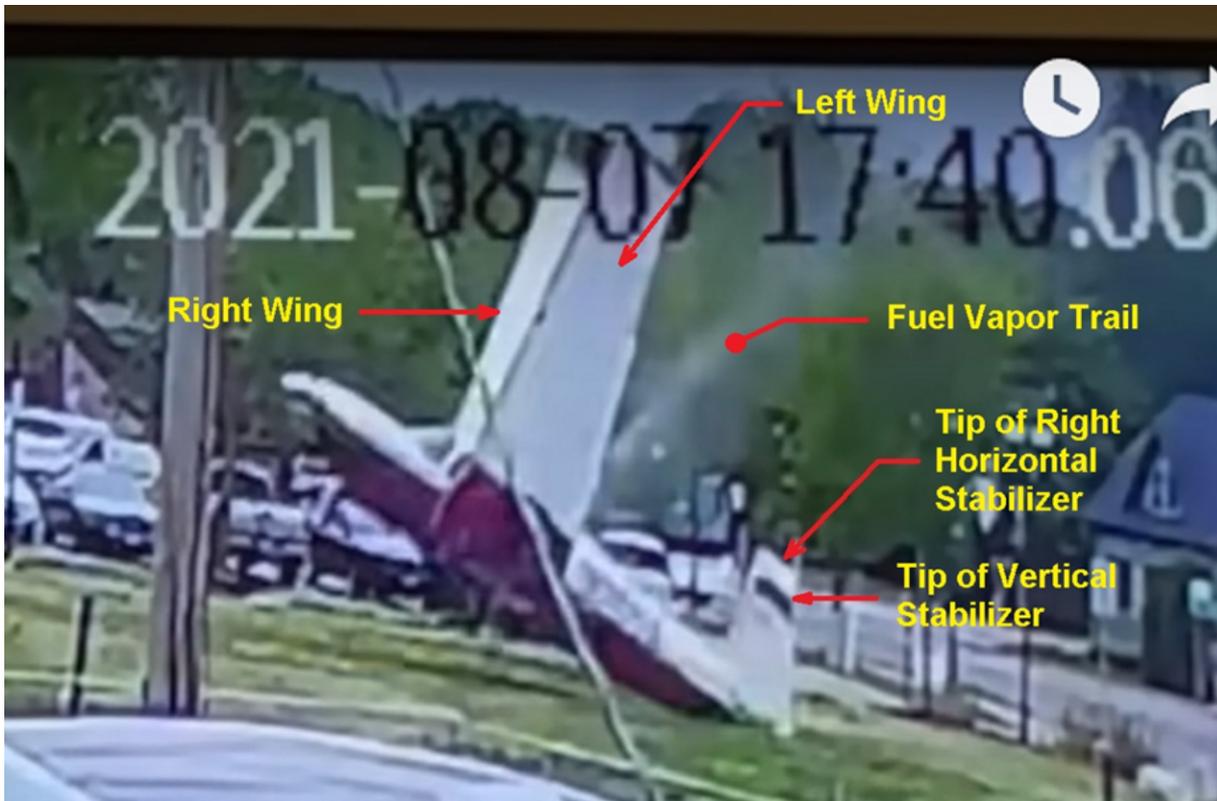
Several witnesses heard a loud popping noise and observed the airplane in a rapid descent with at least one of the wings "folded up." Review of a doorbell security video near the accident site revealed that the airplane was upright and in a nose-high attitude at ground impact and that both wings and the right stabilizer were deflected upward in a vertical position (see figure 1). A King Air pilot who heard the accident pilot's communications with the controller stated that the pilot sounded "stressed" and "confused."

**Figure 1.** Screen capture of airplane just before impact (Source: doorbell security video).

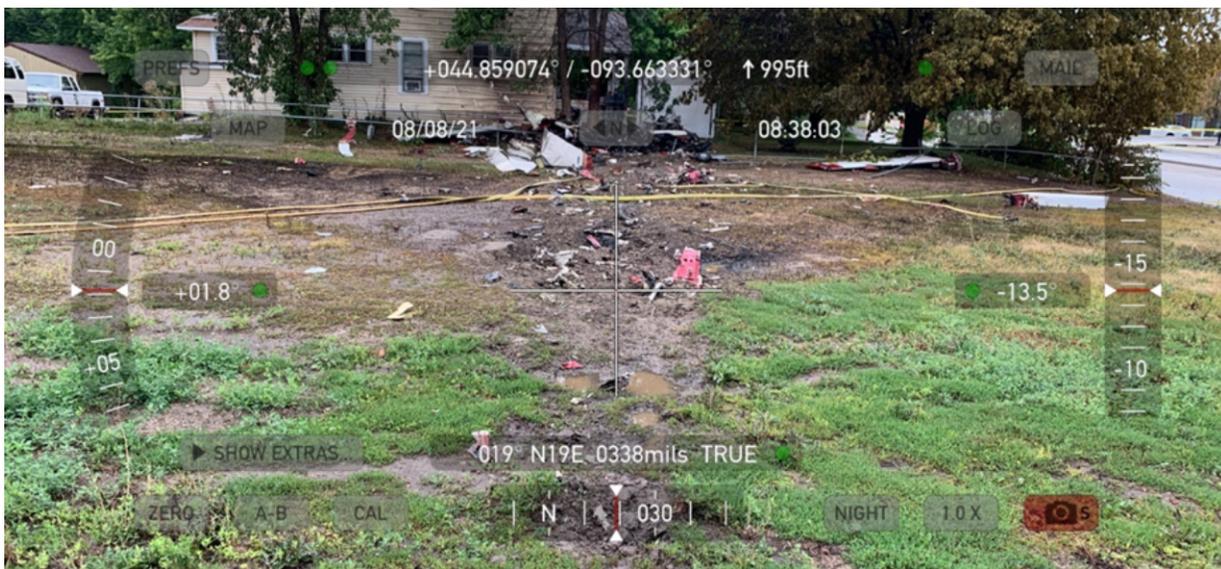
The airplane impacted the ground on a northerly heading (see figure 2). The left horizontal stabilizer and left elevator were found about 720 and 800 ft southwest of the accident site, respectively. A 6-inch section of the main wing spar upper cap splice plate was found about 300 ft southwest of the accident site.

**Figure 2.** Airplane at accident site with parametric data overlaid.

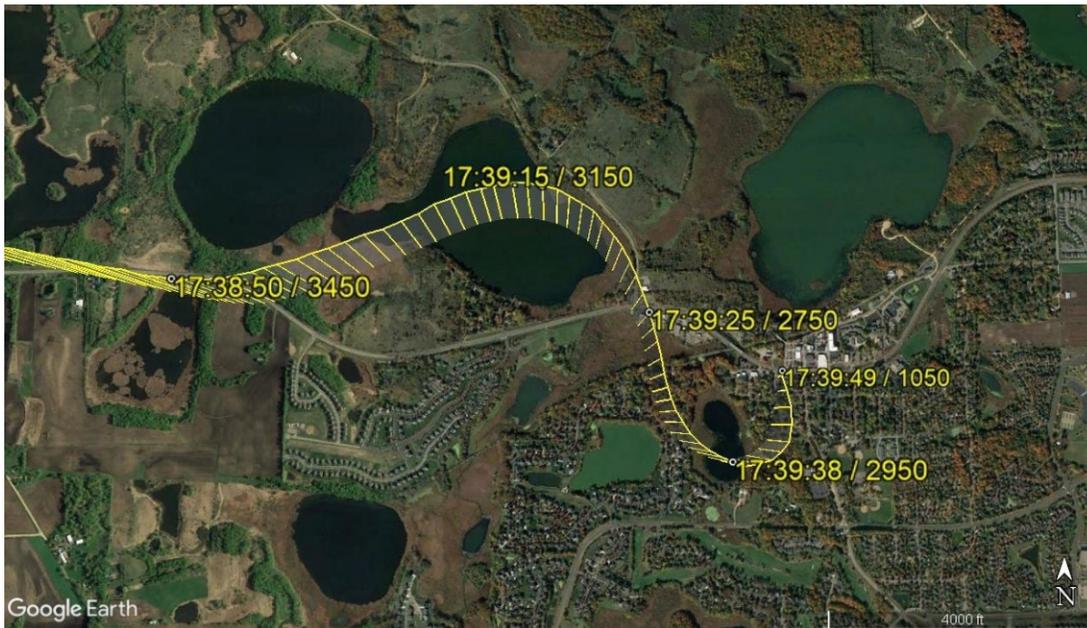
The NTSB conducted a performance study for this accident based on ADS-B data. The study found that, after 1739:00, the airplane made increasingly tight turns at speeds above  $V_A$  (see figure 3).

**Figure 3.** Flightpath showing increasingly tight turns with times and altitudes (in msl).

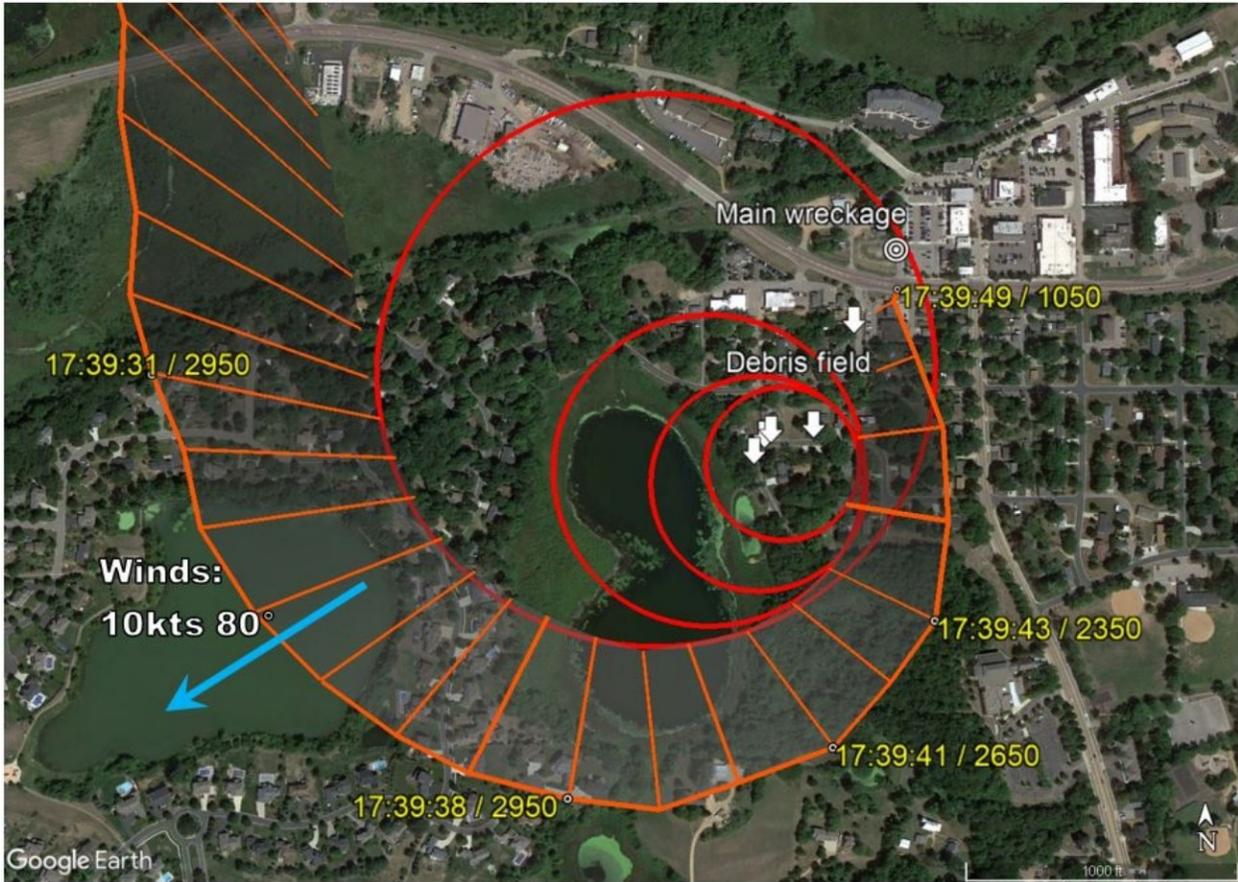
About 1739:25, the airplane began its final left turn. About 13 seconds later, the left-turn radius tightened markedly (see figure 4). The airplane began to descend at more than 7,000 ft per minute, and its airspeed increased to more than 180 knots. As the airplane's left turn tightened and airspeed increased, the resulting bank angle and load factor increased.

**Figure 4.** Final turn with time and altitudes (in msl). The red circles near the center of the figure depict the radius of the airplane’s final left turn at four different points.

By 1739:43, the 4.8-G estimated load factor exceeded the manufacturer’s maximum positive load factor for the airplane. About 1 second later, the increased speed and tighter turn resulted in a load factor that was more than 8 Gs. From 1739:43 to 1739:45, the airplane’s groundspeed increased about 40 knots, and the left turn rate accelerated with a 046° heading change. During this same 2-second timeframe, the airplane descended below the altitude of the overcast cloud deck.
